XS750/850 FINAL DRIVE CONVERSION....THAT ELUSIVE 6TH GEAR!

XS750 Final Drive Conversion

by Cody(Maximan) and XSChop, posted 11-12-06

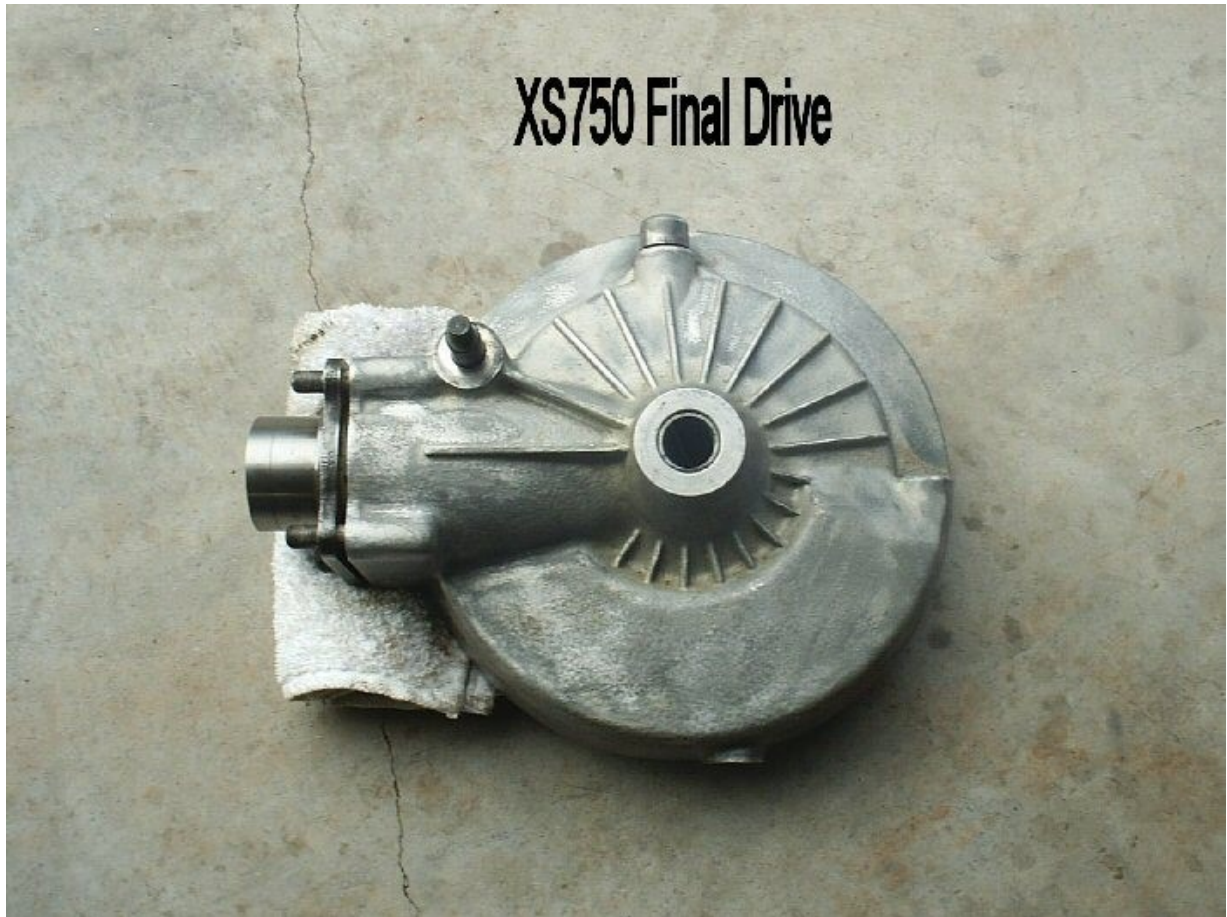
I stripped all the old paint (silver) off the unit as I will paint it black to match the oem drive. Notice the XS750 has lubrication (spooge) holes in the base of the gear coupling. The 750 shaft also incorporates an oil seal that allows oil to circulate into the

coupling house and lube the drive spline. The seal on the 750 shaft contains the oil in the gear coupling.

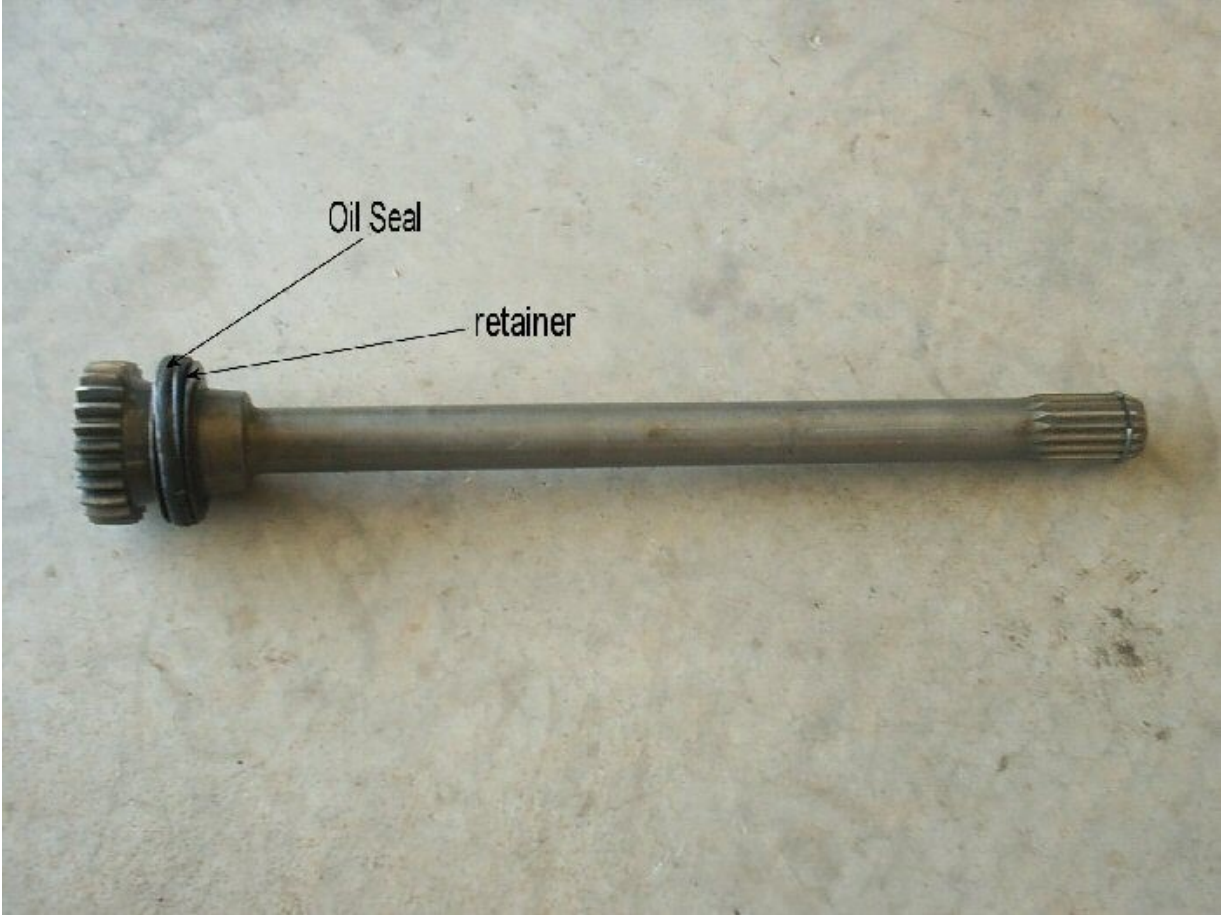
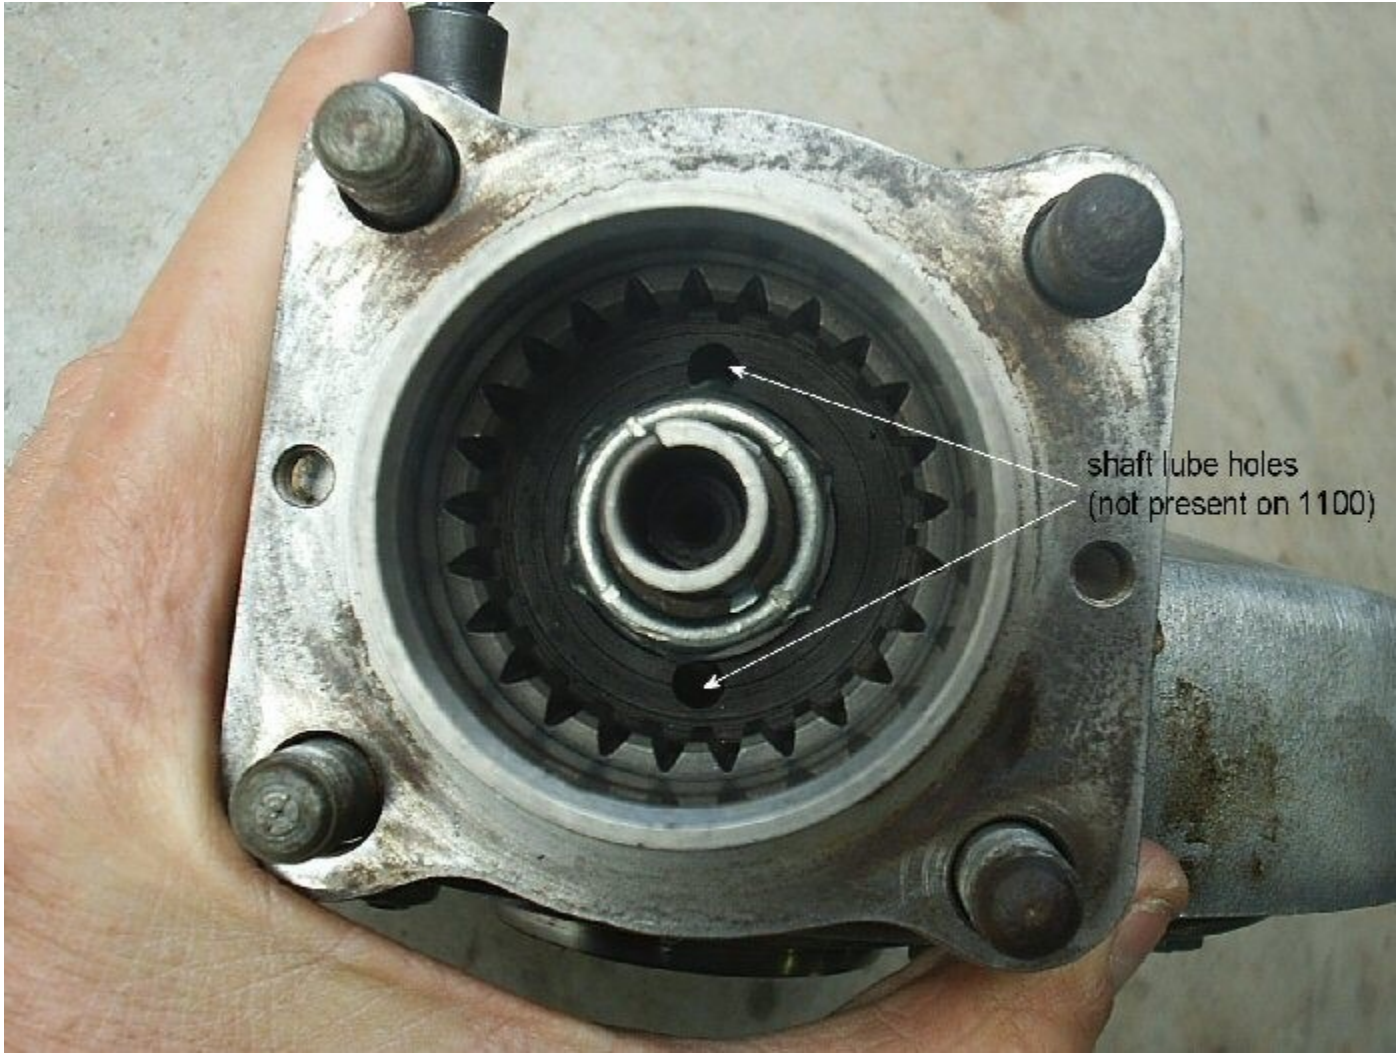
XS750 shaft
10 - 13/16"

Eleven shaft
10 - 1/8"

Also notice how the spline are recessed into the gear coupling. This recession is where the shaft seal seats to retain gear oil. The Eleven does not employ this style of lube system. The Eleven has no “spooge” hole and uses instead grease. Personally I think the Eleven is a superior system. With the Eleven there is no possibility of oil seal failure and thus leaks. So I sealed the spooge holes in the 750 drive with liquid gasket and covered them with a standard ½ flat washer (the perfect size by virtue of serendipity).

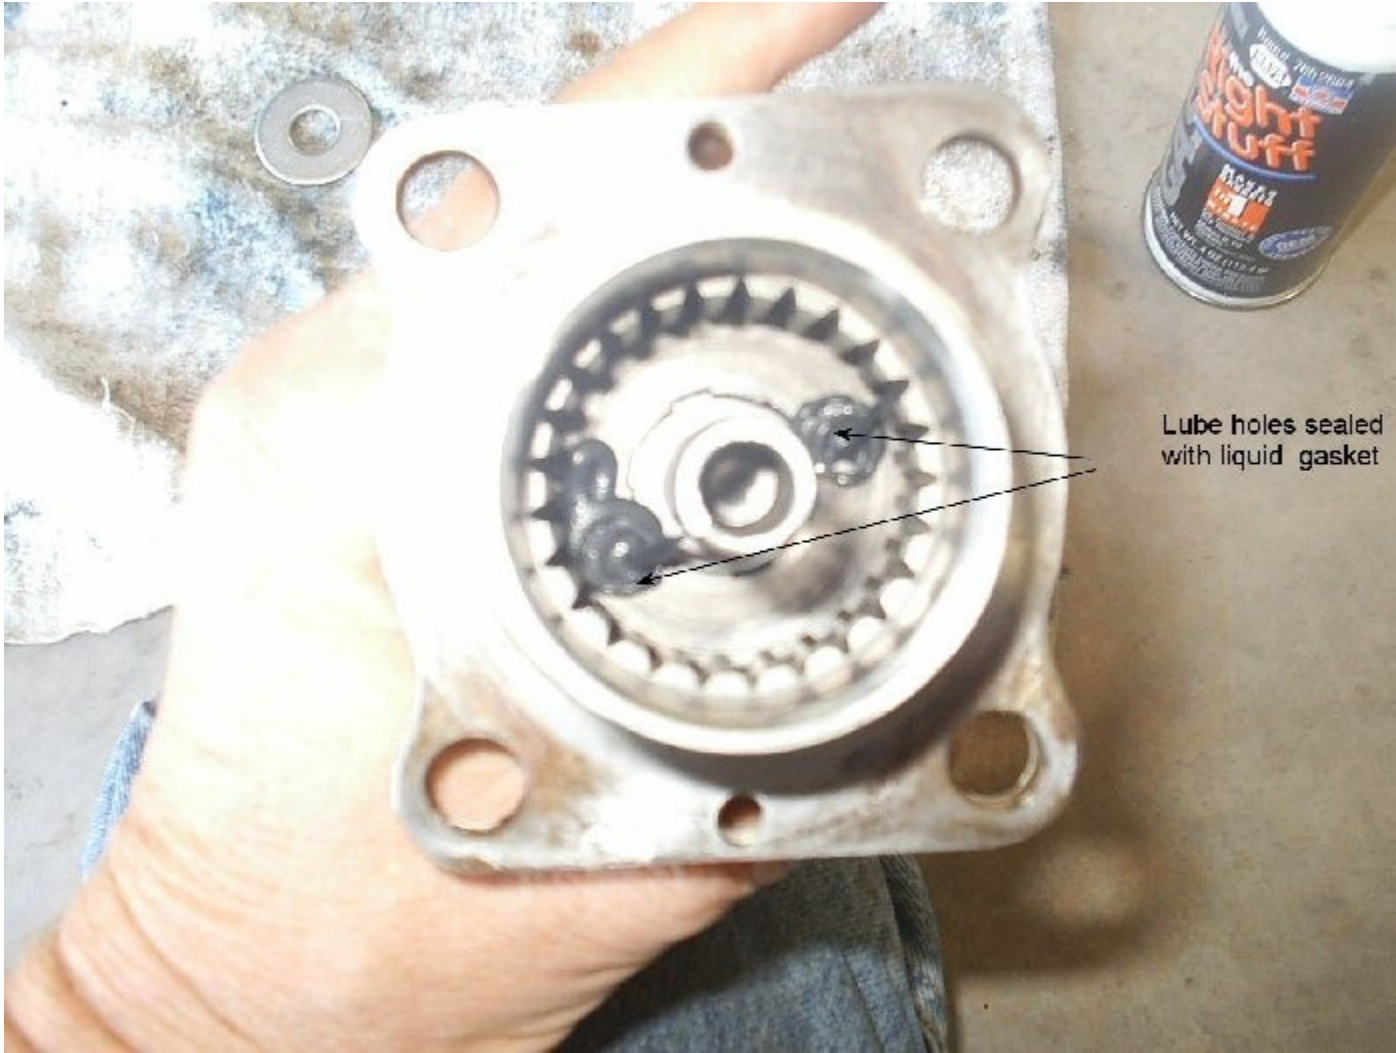
Lube holes sealed
with liquid gasket

Next put a thin film of sealant on the back of the washer. Replace the spacers (if applicable), then the 1/2" washer, and pinion retainer nut. Then tighten by hand only.

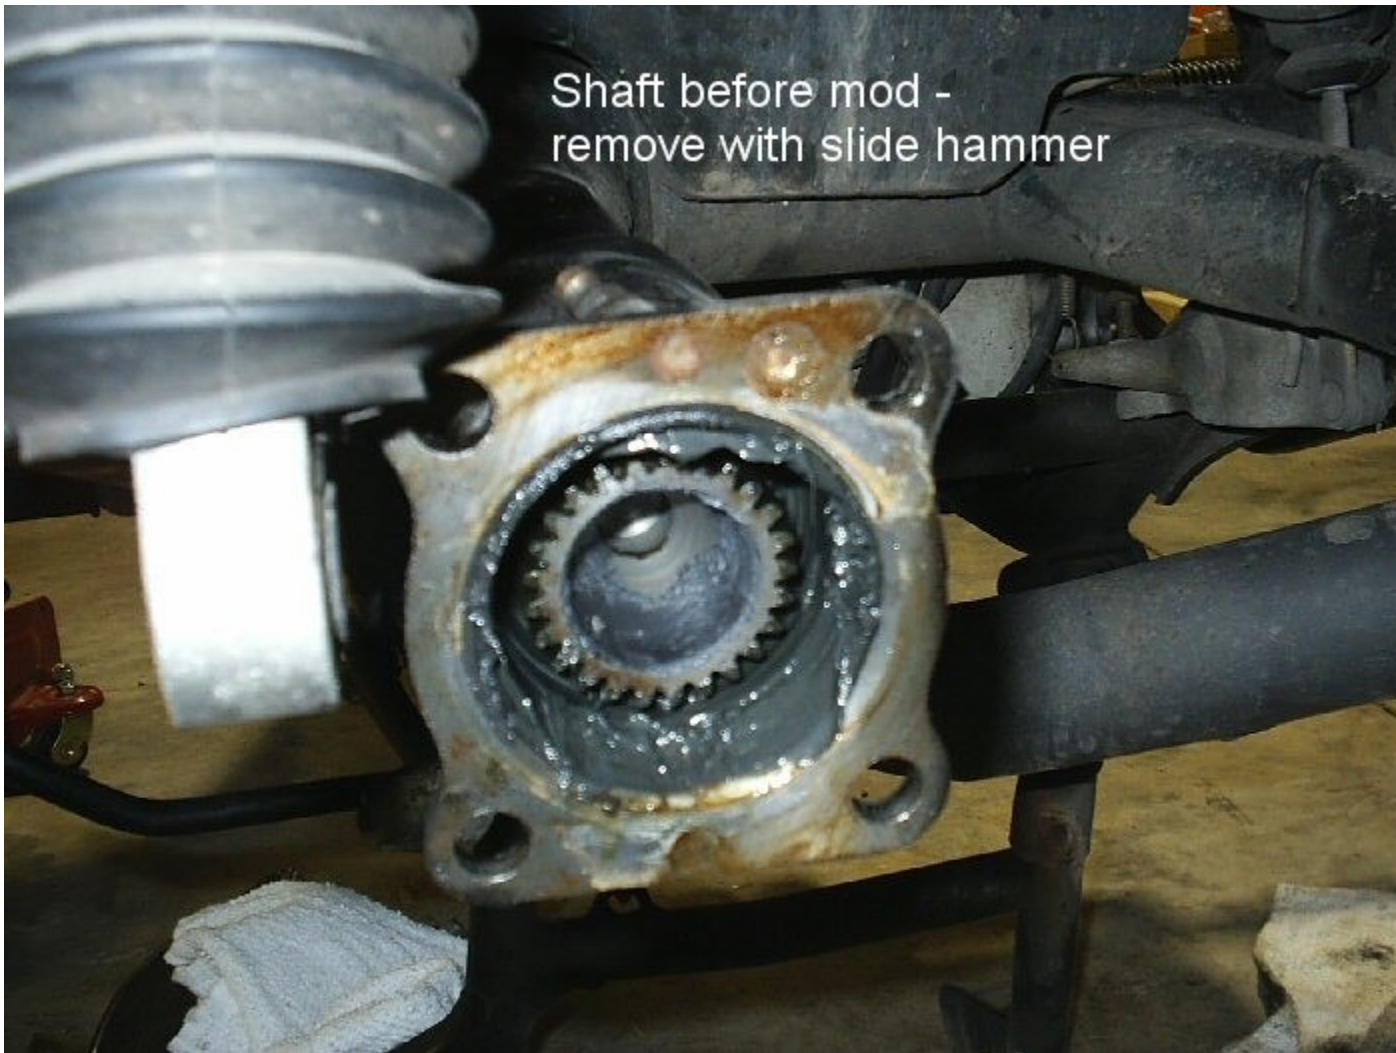
Now you can measure the distance of the shaft face to the housing face. Then measure the distance of the XS750 drive housing face to end of the splines. This will tell you exactly how much spacing you need for a collar or length to extend your shaft. Depends on which route you take. In either case it turns out you'll need about 5/8 to 11/16 inches (16 to 17 mm).

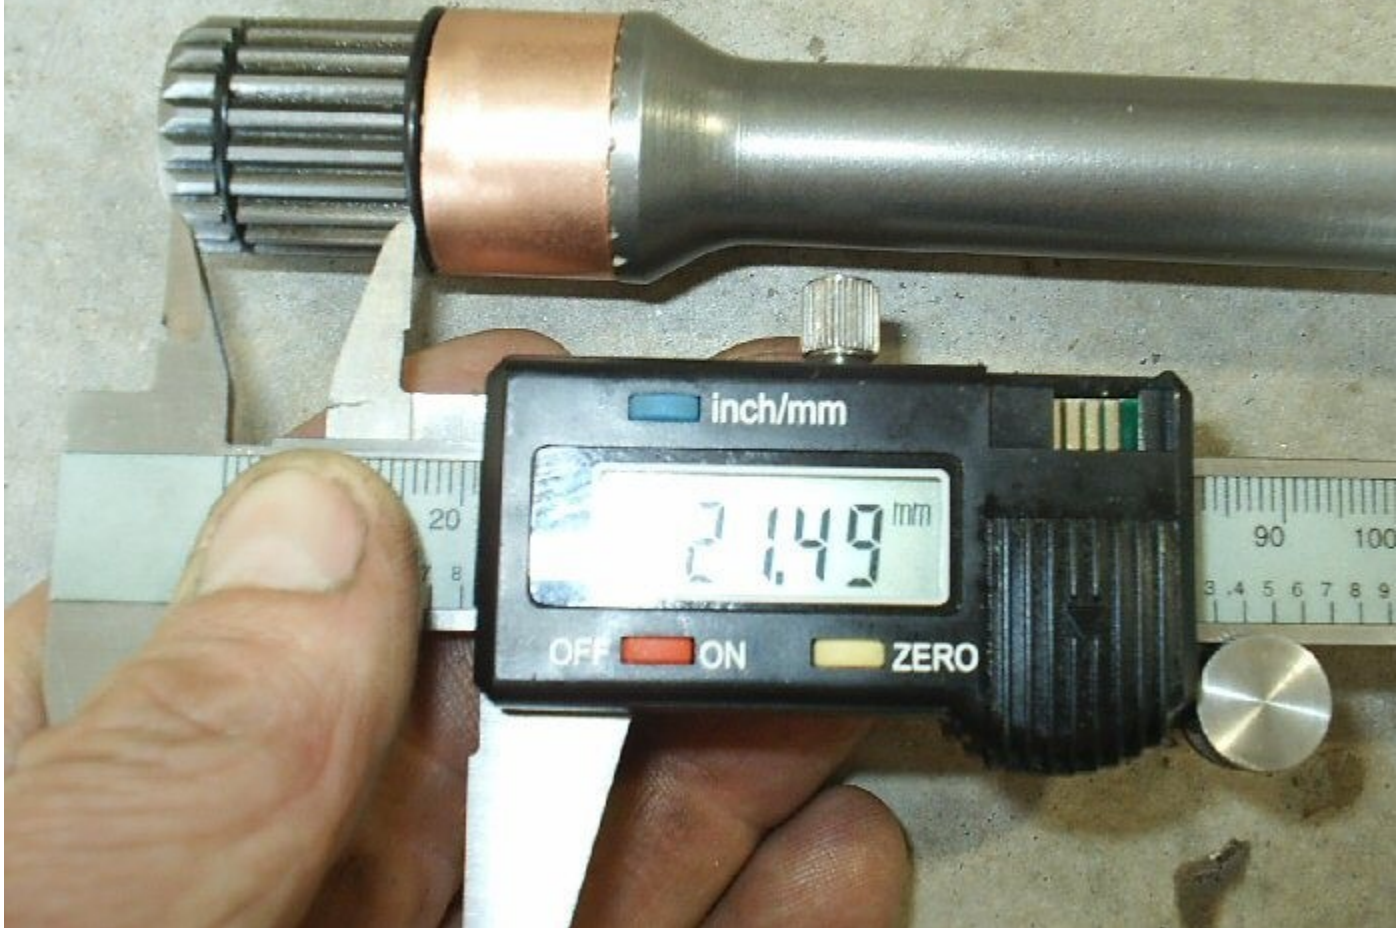
Engaged spline length after mod - 21.5 mm

After all this modification you can now see there is still 21.5 mm of spline length to engage the yoke. We've only lost less than 3mm of spline length. This should barely compromise the strength of the spline interface. Plus using this mod method we have not compromised the torsional strength of the shaft. And last but not least...this method cost a fraction of the other. Again...kudos to Chop for figuring all this crap out. I am merely the messenger relaying the procedure to all the brethren. 🇺🇸
