XS750/850 FINAL DRIVE CONVERSION....THAT ELUSIVE 6TH GEAR!

XS750 Final Drive Conversion

by Cody(Maximan) and XSChop, posted 11-12-06

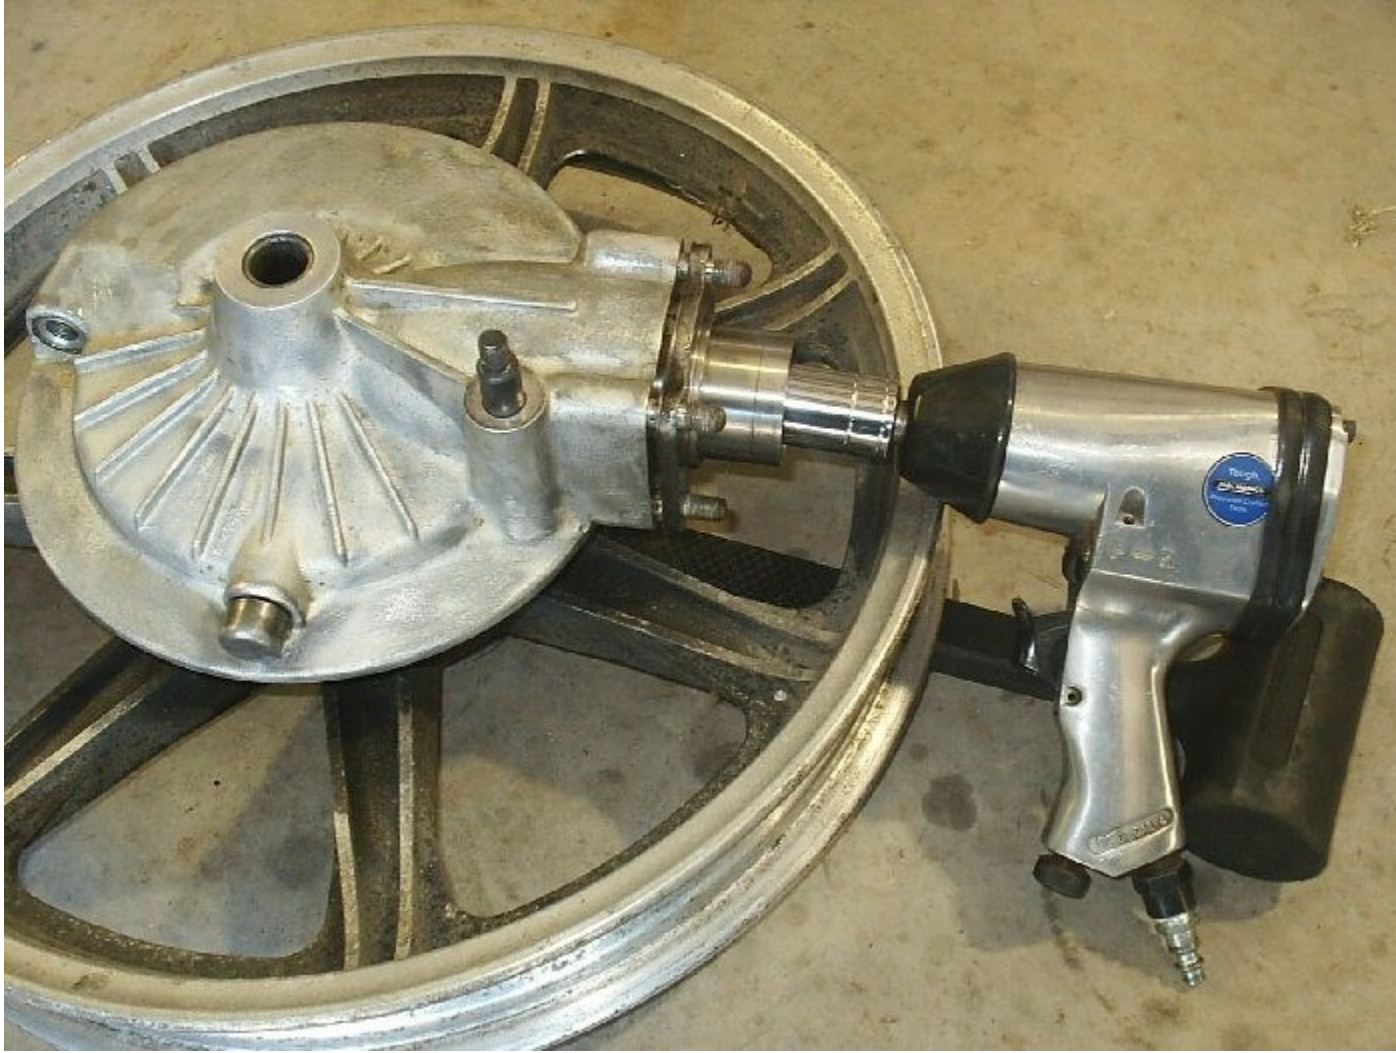
First to remove the pinion retainer nut as seen above you’ll need to have some way to hold the ring gear backup while you break the pinion retainer. I used an old XS wheel I had , then a 22mm socket on an air impact.

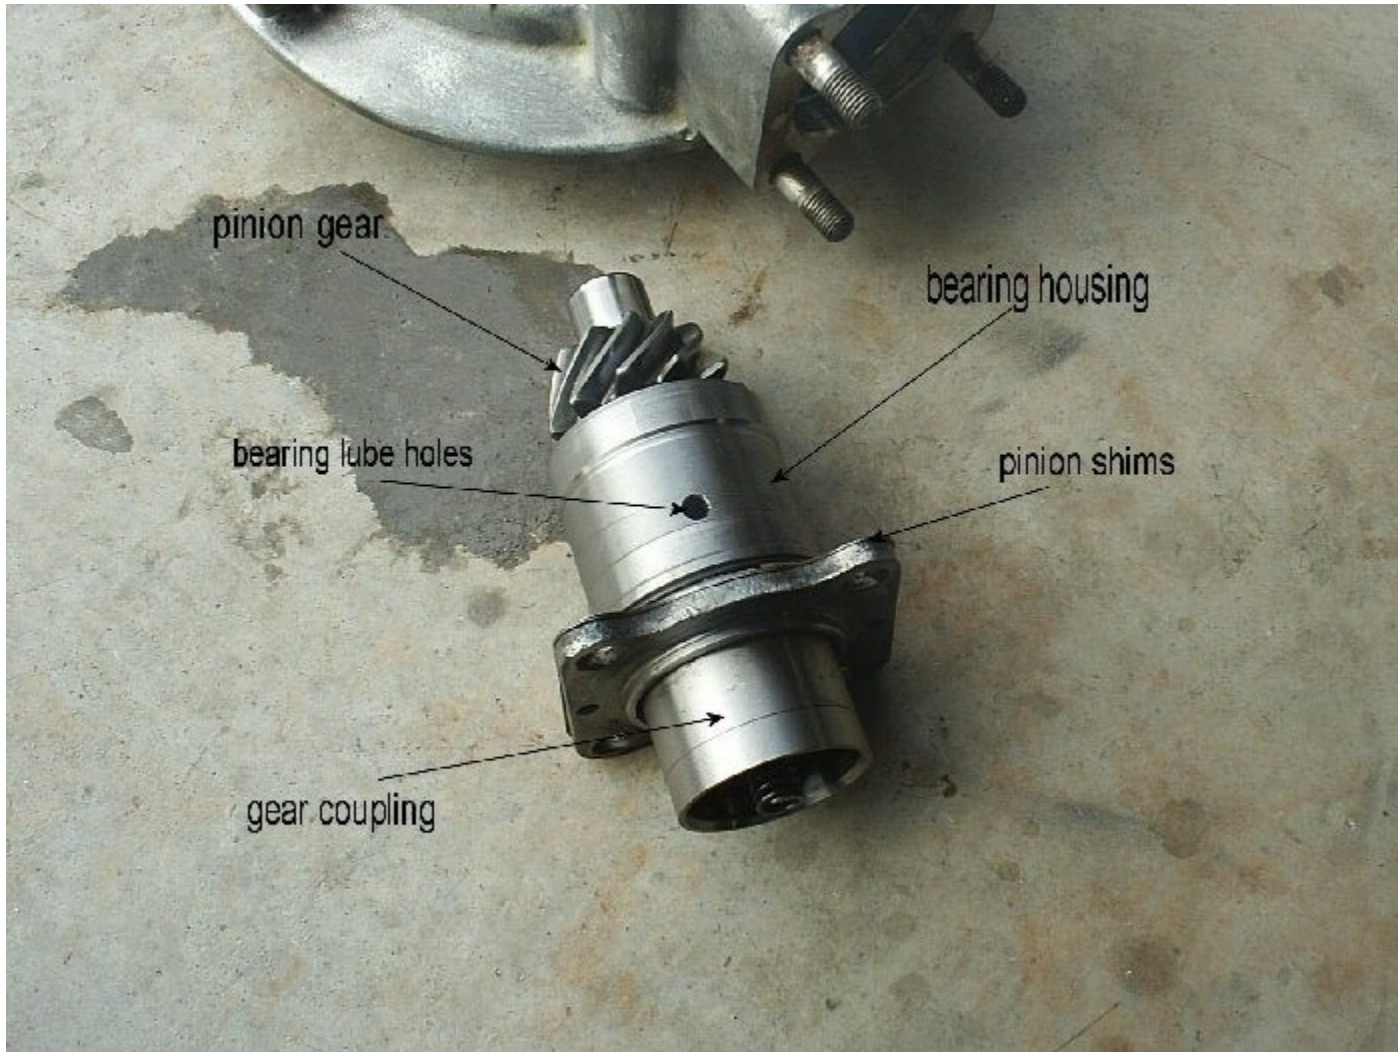
Next I removed the pinion assembly. When Chop removed his he said only the gear coupling came out and he never saw the pinion gear. My didn't break there. The whole pinion assembly came out. No big deal.

The gear coupling is what receives the splines on the drive end of the shaft. Remember the lube holes and pinion shims. We'll touch on these later.

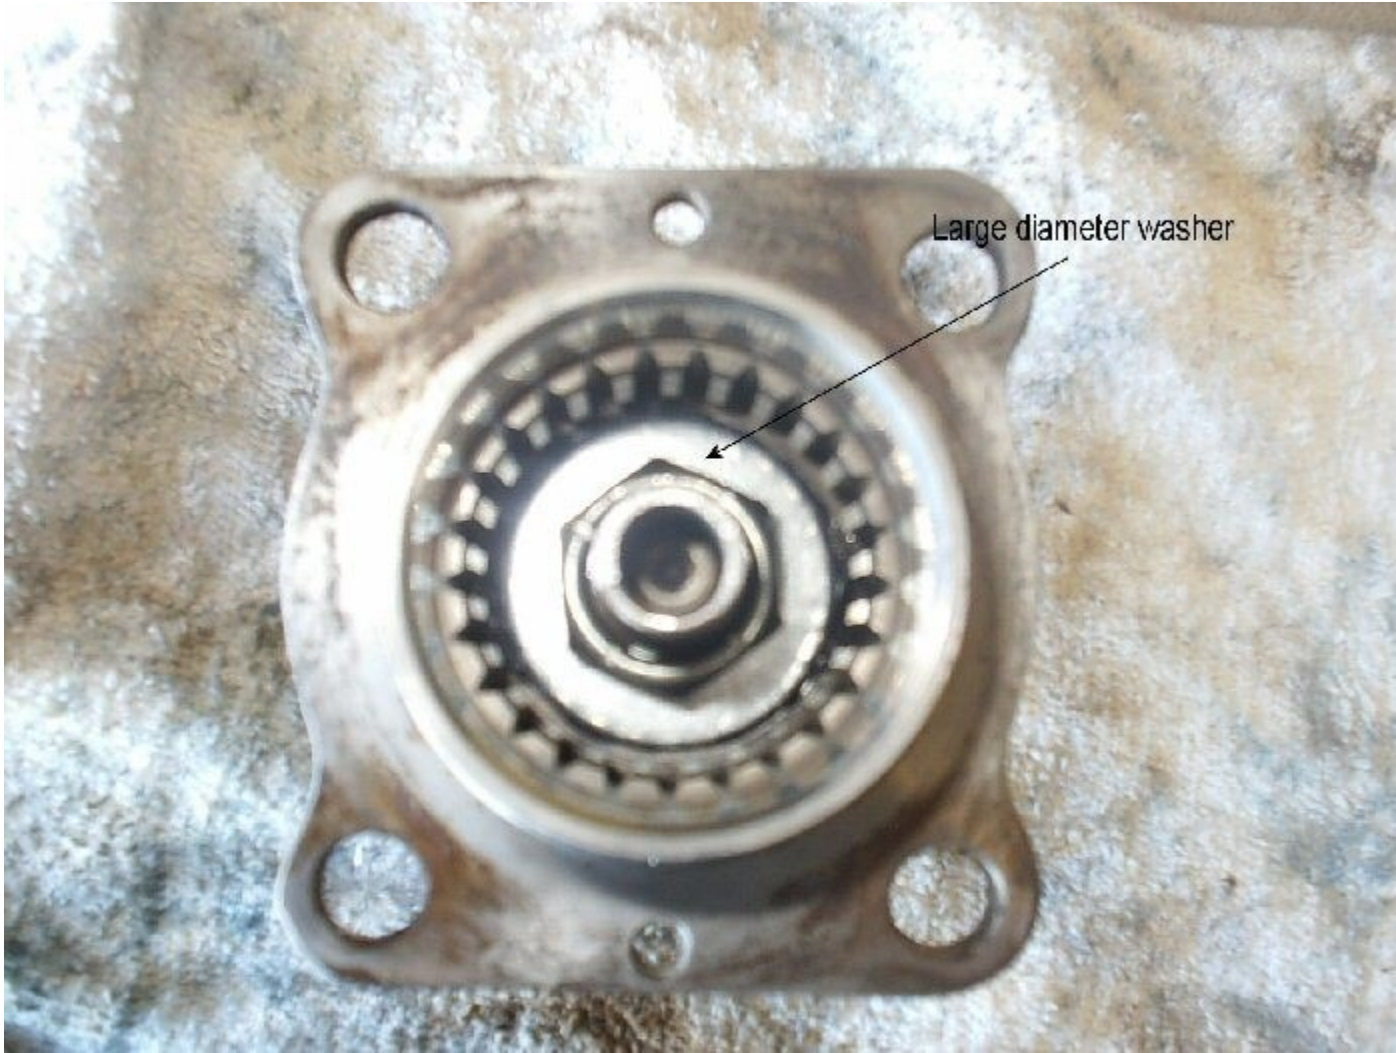
Next put a thin film of sealant on the back of the washer. Replace the spacers (if applicable), then the 1/2" washer, and pinion retainer nut. Then tighten by hand only.

Now put a little sealant around the bearing housing...where it seats back into the drive housing. This will insure a good seal so no gear oil will leak from the interface. Yes yes there is an o-ring seal but I am always extra cautious. Besides the OEM housing appeared to have Yamabond on it upon disassembly.

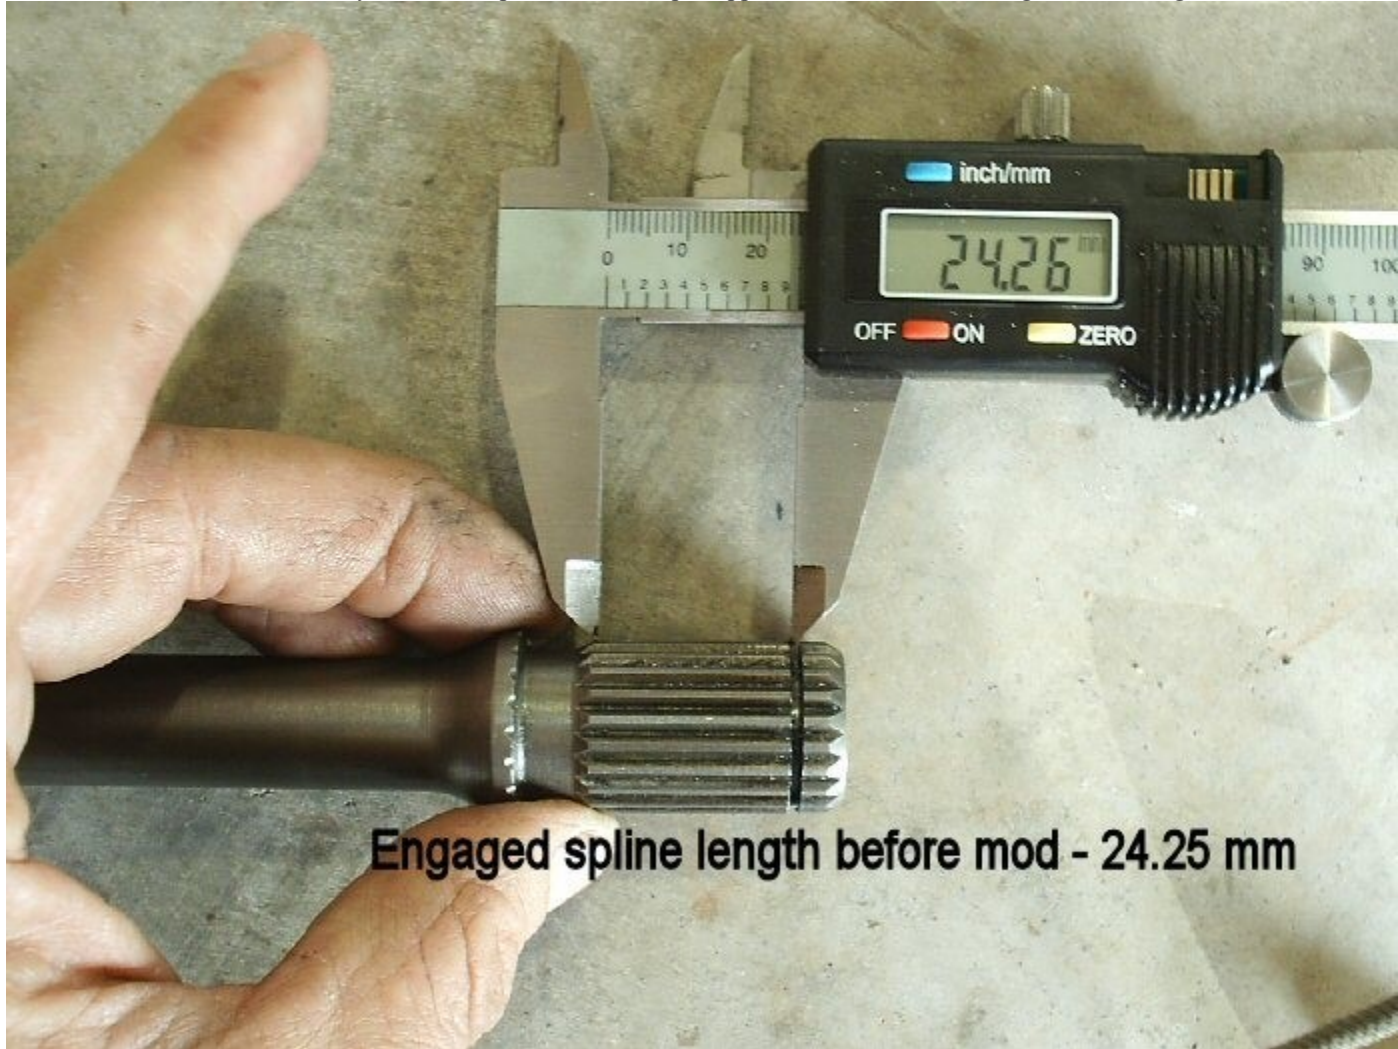
There is no need to jump through all these hoops when a simple spacer (copper bushing) can be made to effectively accomplish the same task. Upon studying the Eleven's splines that interface with the U-joint yoke I could see that about 24 mm of spline is being utilized. Notice the 3mm or so splines beyond the circlip groove are not used in the OEM configuration. These splines protrude past the u-joint yoke receiver and a circlip holds them in place. I have yet to ascertain why the circlip is there. There is no way for the shaft to ever come out of the yoke once in place. The circlip appears to be some "over-engineered" design.

Next I cut a 3/4 inch copper sweat coupling (like you'd find at a hardware store)...I cut it 16mm long.

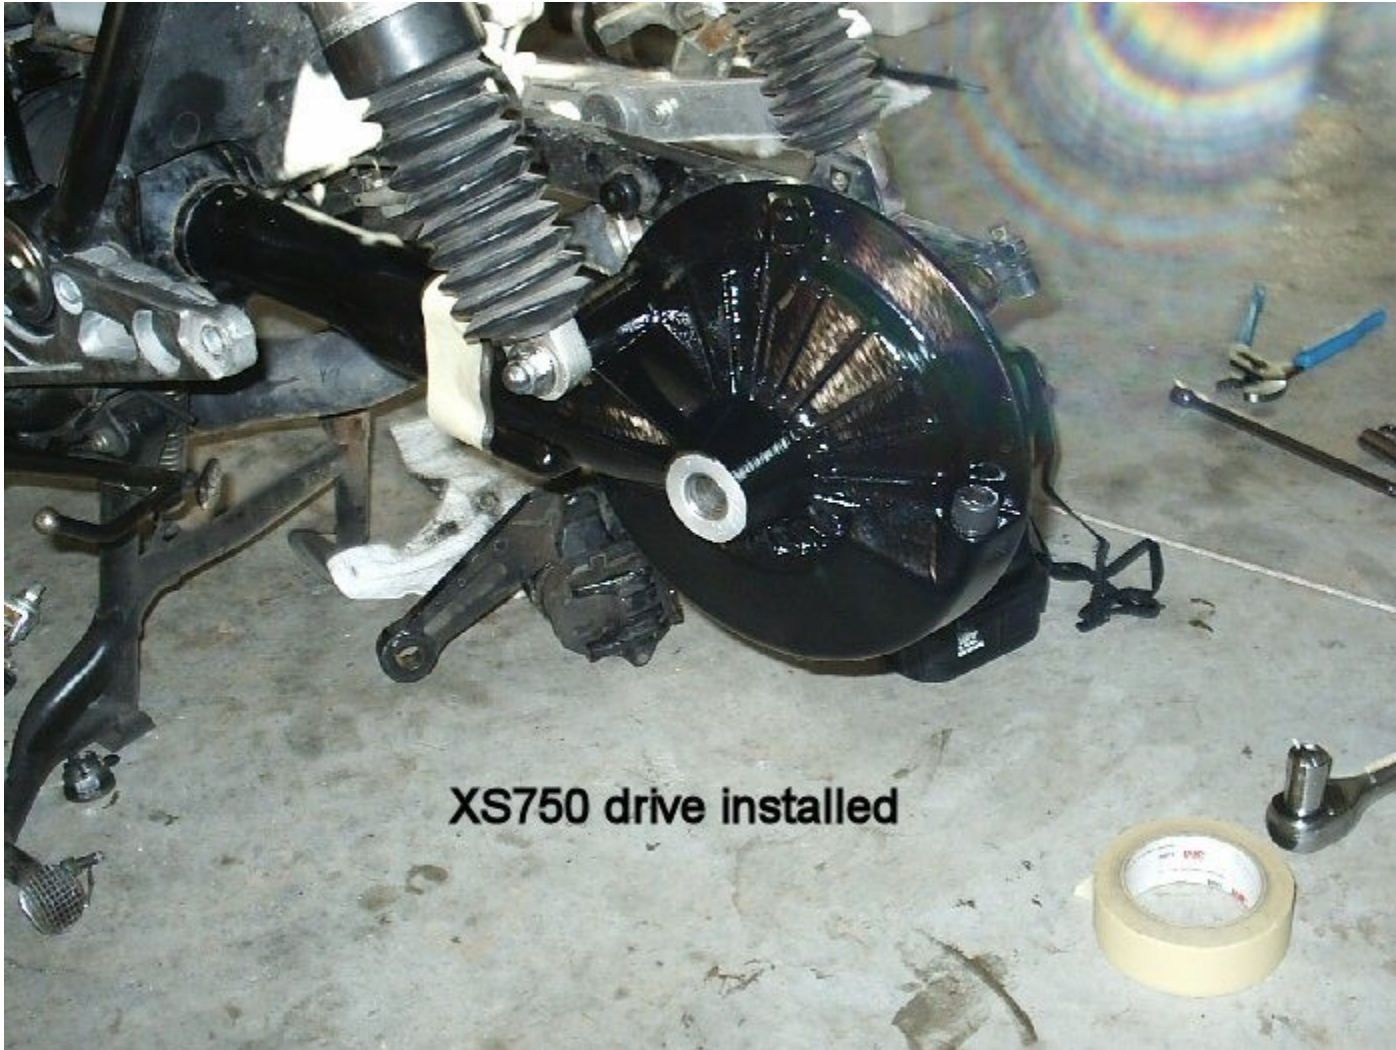
Don't forget to fill the 750 drive with 90 wt gear oil. What shame to do all this work only to burn up the newly installed drive. 🤖
Oh yes ...and pump the shaft housing full of grease...you know at the shaft housing grease zirk. Dan Hodges tells me the spec calls for 30 cc of grease and that a standard grease gun is 1 cc per stroke. Do the math.

Re-install the rear wheel (grease those splines slightly too)...button and bolt everything back up. Now RIDE!!! And watch you gas mileage FLY!!! 🍀 You top end speed should be to shabby either.
